# CB Model Gearbox Rebuild

By frogcow

Specs : G11 Cb23 manual gearbox

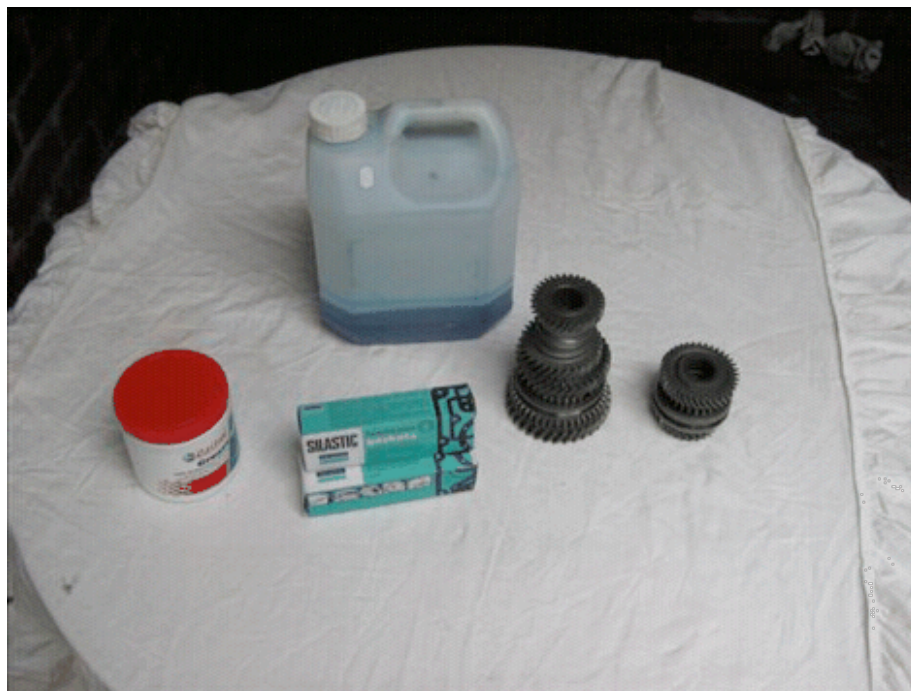
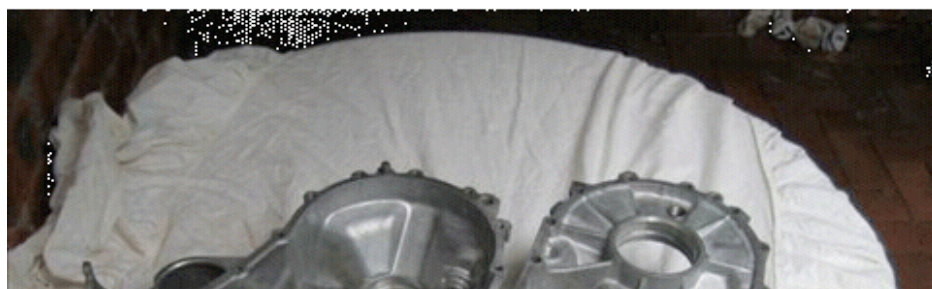
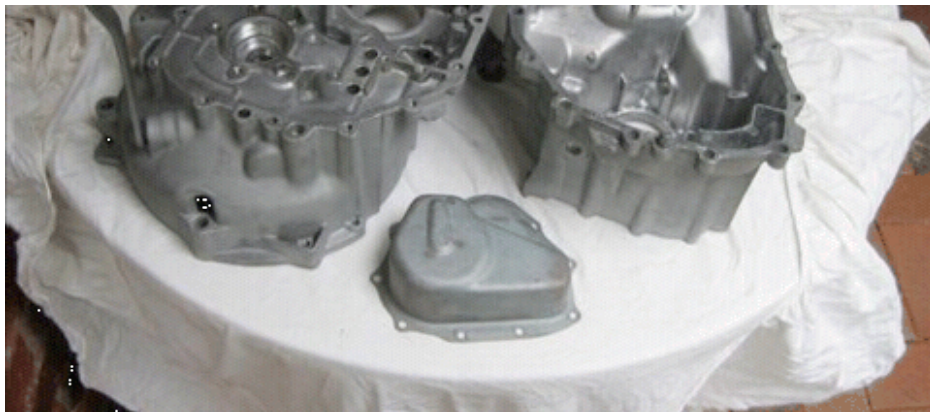
The guts were stripped and washed and scrubbed in general kerosene with a toothbrush, the insides of the casing were sprayed with Motortech degreaser and then washed with hose:

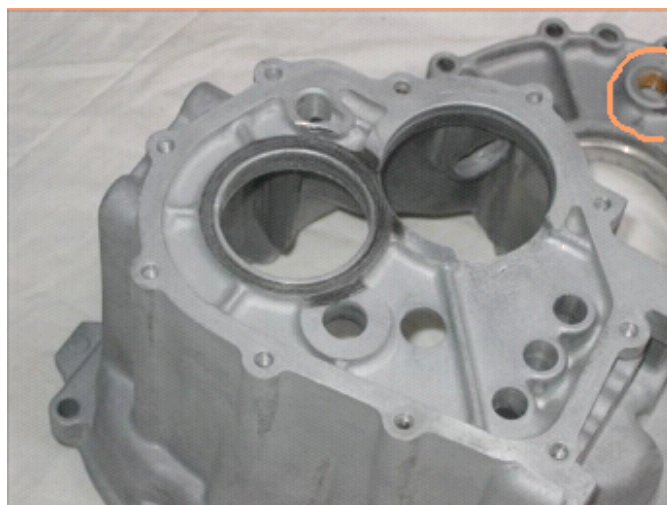
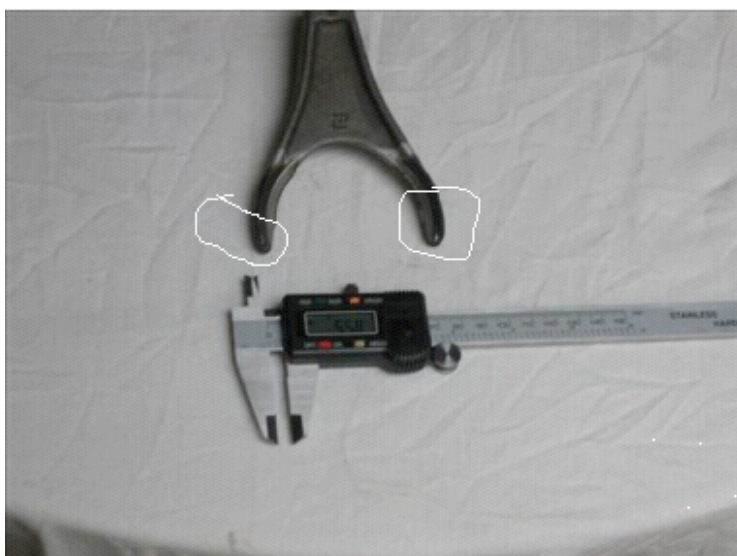
The separation of the two casings had to be done by the gearbox specialist it was taken to because it was stuck tight. They also gave me a few pointers and tips for free. The filler plug thread was covered in some varnish because it had been stripped; this casing was taken to an engineering firm for an insert and new thread:

The entire casing was sandblasted using 1mm paving sand, a cheap sandblaster gun from Repco and a small 2.5hp air compressor:

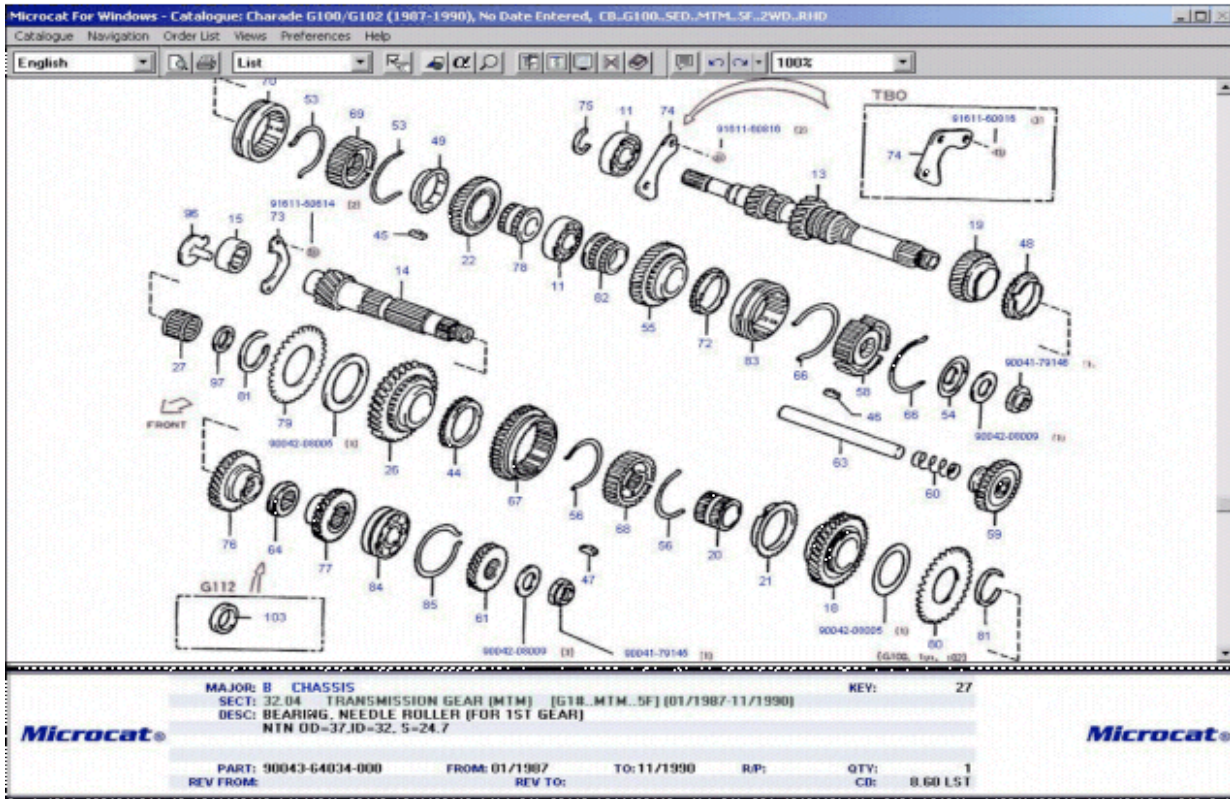
There was excessive wear on the casing under 5<sup>th</sup> gear and the shift fork and clutch hub for 5<sup>th</sup> were below the limits allowed in the manual, 2<sup>nd</sup> hand replacements were found.

Apart from the problem with the wear surrounding fifth gear the G11 box didn't have a washer 87 found in the G100 box and output shaft cover (no 96). The gearbox had signs of being opened up post factory, blue, red and clear gasket glue remnants were found:

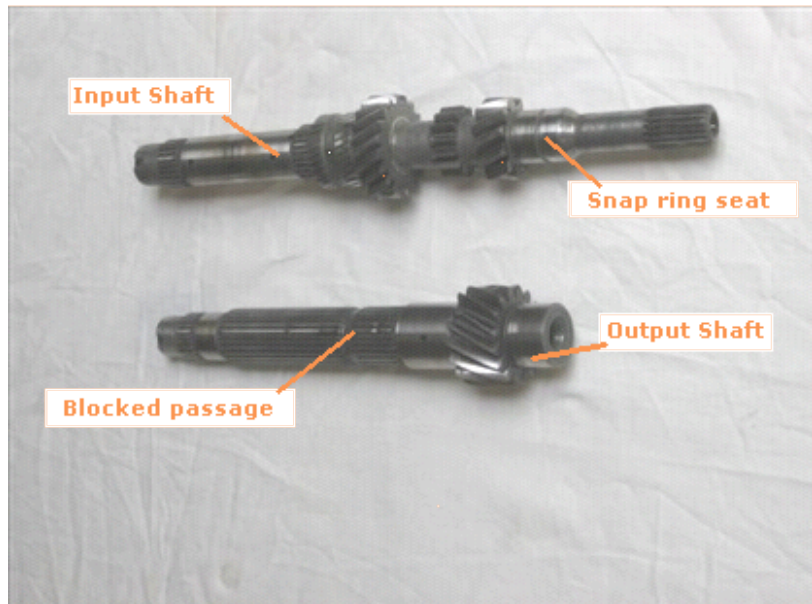
The hole that feeds oil to this bush was completely blocked with some black bits of plastic. Snap rings were replaced with new ones by using two screw drivers the same height, and hitting them both at the same time whilst the shaft was locked in a vice, a cloth was placed around the shaft when locked into the vice to avoid scratches. Same with removing the snap rings, care was taken not to scratch the journal area around the seat. As you can see from the picture below there is a seat for one on the input shaft towards the right end. The shaft on the bottom of the picture is the output shaft; it has two snap rings, one in the first gear assembly and one in the second gear assembly.

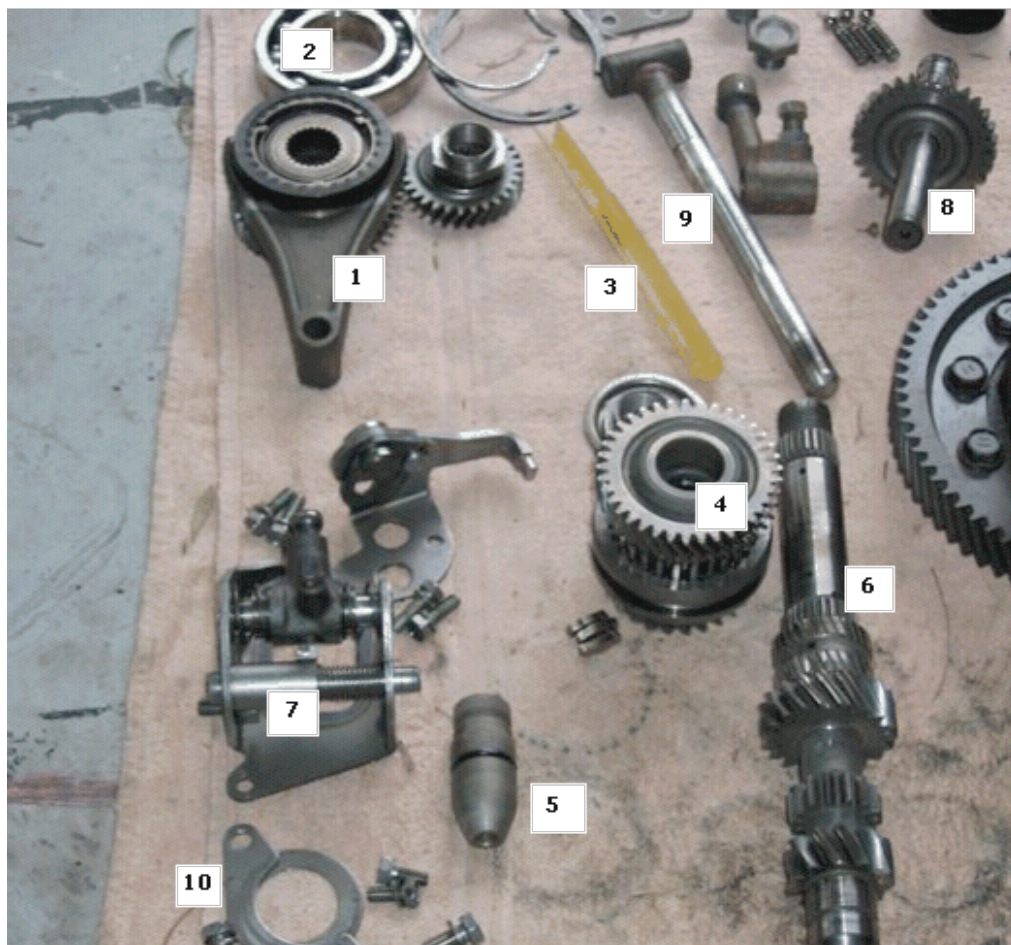
1	5 <sup>th</sup> gear assembly, shift fork, clutch and clutch hub and one of the lock nuts	6	The input shaft
2	The largest bearing in the gearbox, one of two on the diff	7	Selector support assembly
3	Case cover oil pipe	8	Part of the control linkage, 1 of 4 parts
4	Gear assembly from the input shaft	9	Shifting bell crank
5	The speedometer shaft sleeve	10	Output shaft needle roller bearing cover

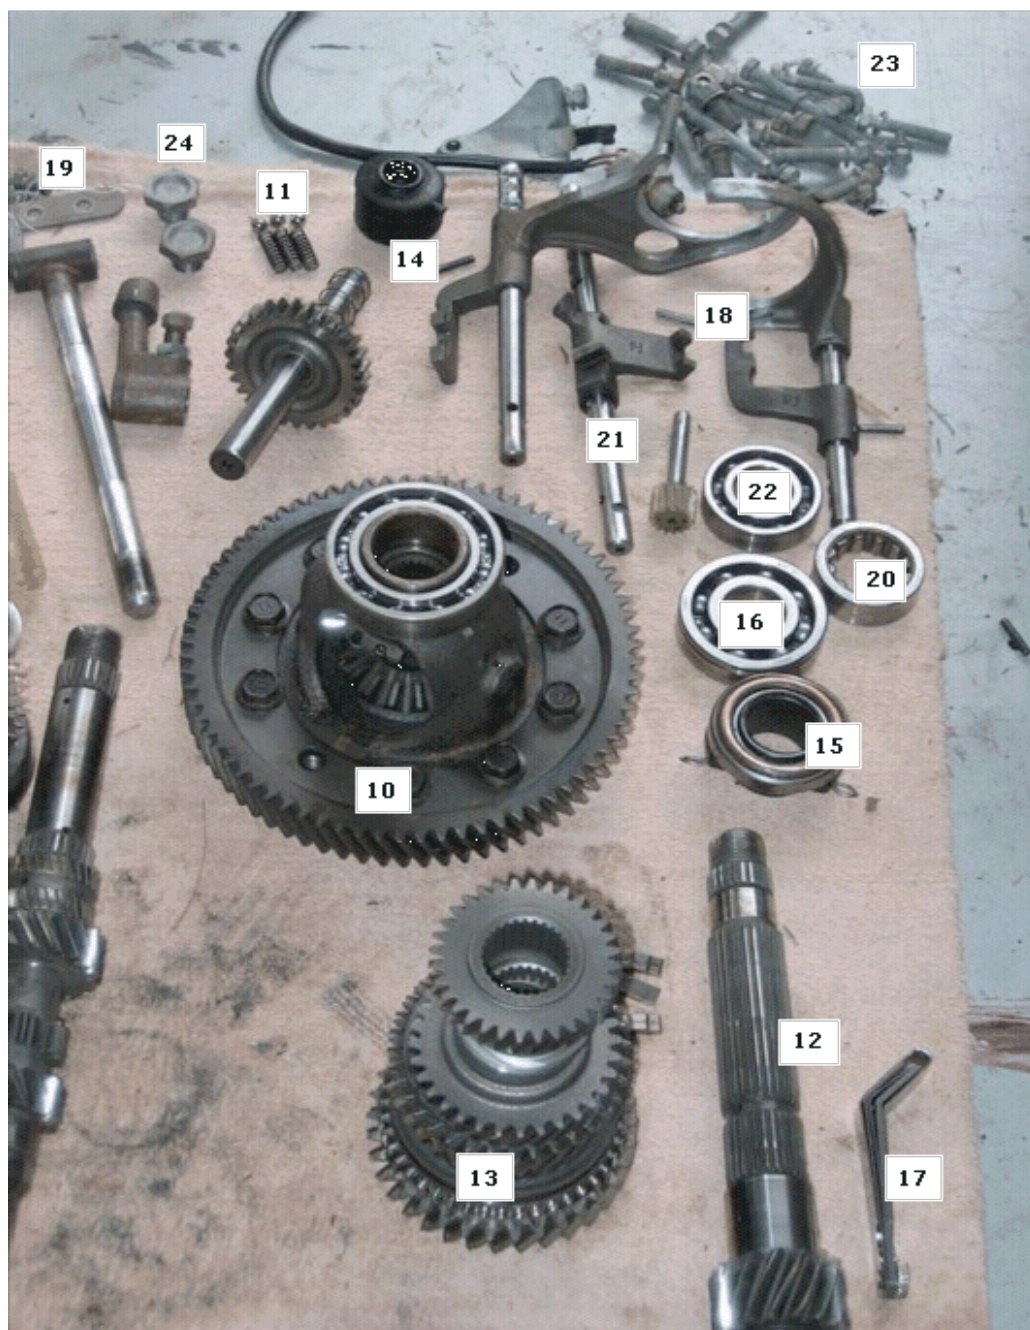
11	Compression springs and balls	18	The other three of the four parts of the control linkage
12	Output shaft	19	Lock bail plate
13	Gear assembly off the output shaft	20	Needle roller bearing on output shaft
14	Shifting crank boot	21	Speedometer gear
15	Clutch bearing	22	Roller bearing from input shaft
16	Bearing on the output shaft under 5 <sup>th</sup> gear	23	Gearbox casing bolts
17	Feeler gauges	24	Filler and drain plugs
